# Manhole Inspection Summary

Manhole # S71U\_\_009MH

**Location** Address: **6929 Holabird Ave.**

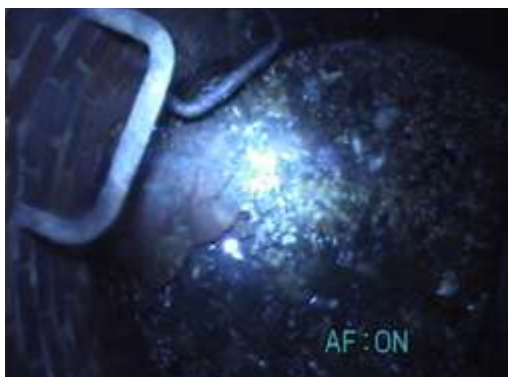
Defect 4

debris on bench

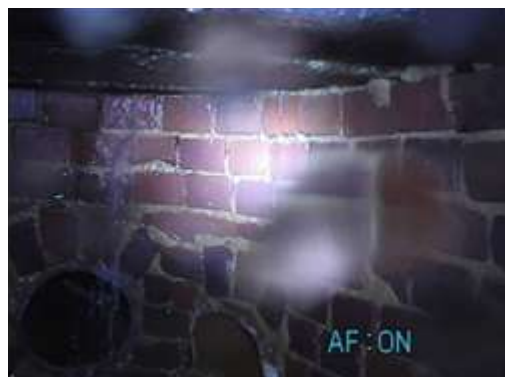
Defect 3

Comments **HEAVY INFILTRATION GUSHER WHERE CORBEL MEETS THE BARREL. 5 GALLONS PER MINUTE. CITY MAY WANT TO REHAB ASAP. INSPECTED AT NIGHT. I MOVED THIS TO A "5" RATING .RES WILLIAM CHASE FROM BALTIMORE CITY PW CONTACTED ME 3-24-09 ABOUT LOCATING THE MH. I MAR**

Condition: ☐ Sound ☒ **Cracked** ☐ Root Intrusion ☐ Loose Brick ☐ Deteriorated

Infiltration: ☐ None ☒ **Joint** ☒ **Cracks** ☒ **Mortar** ☐ Roots ☒ **Wall**

infiltration gusher where corbel meets the barrel

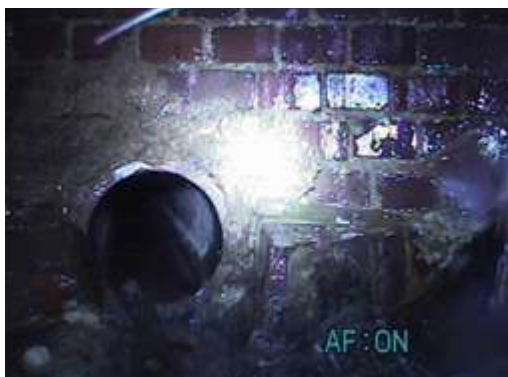
Defect 1

Condition: ☐ Sound ☒ **Cracked** ☐ Root Intrusion ☐ Loose Brick ☐ Deteriorated

Infiltration: ☐ None ☒ **Joint** ☒ **Cracks** ☒ **Mortar** ☐ Roots ☒ **Wall**

infiltration running down the wall by I2

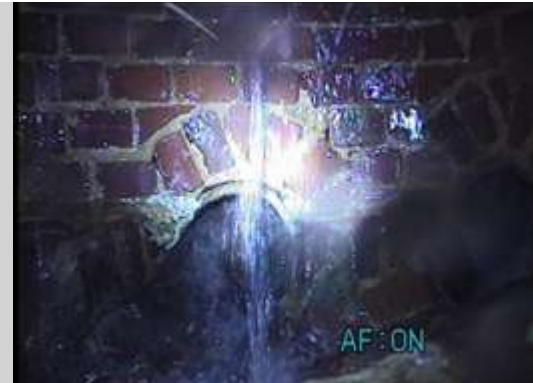
Gusher dropping water in front of I4

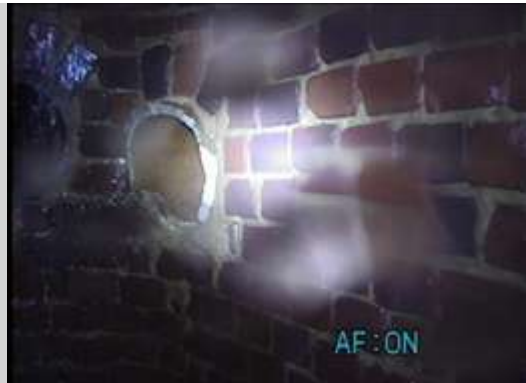
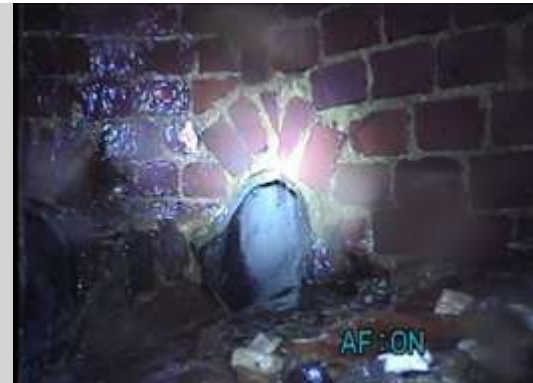
6 O'Clock Inflow

Deposits: ☐ None ☐ Mud ☐ Sludge ☒ Debris ☐ Grease

Silt Depth: 0.25 (in.) Deposits Extent: Light
